## WORLD'S LARGEST OFFSHORE DRILLING CONTRACTOR STANDARDISES ON FLIR

*Conditioned based monitoring using FLIR Systems infrared cameras has become a standard for the European and African (EAU) operation of Transocean Inc. Last year the company provided each of its rigs with their own FLIR Systems camera and now as a result of the merger between Transocean and GlobalSantaFe Corporation, this technology is being investigated for implementation on the remaining legacy GSF rigs, to ensure standardisation of equipment across the region's combined fleet of 57 rigs.*

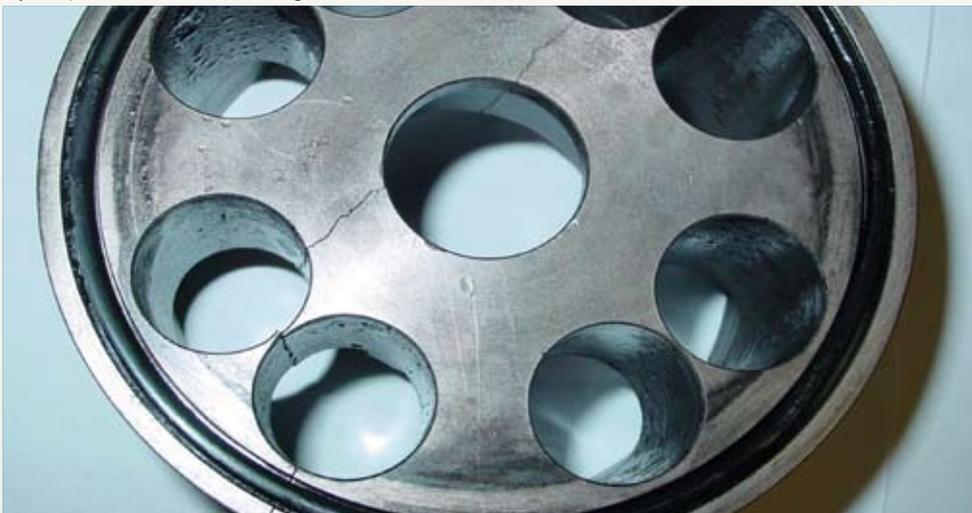
*Glycol Pp Suction Vv Guide Damage*

"With my FLIR camera I was able to prevent this unnecessary procedure," Bob continued. "By looking at the thermal pattern on the second, healthy glycol pump and using that as a benchmark, I was soon able to pinpoint the problem to the suction valve. A quick examination of the suction valve soon revealed one of the guides was cracked." The faulty component was swiftly replaced saving in the region of 12 hours labour.
